# Marshall County Courthouse Facility Assessment

October 09, 2020

Josh Muckenhirn, AIA  
*Architect*  
ISG  
101 South Reid Street + Suite 202  
Sioux Falls, SD 57103  
605.274.6401  
Josh.Muckenhirn@ISGInc.com

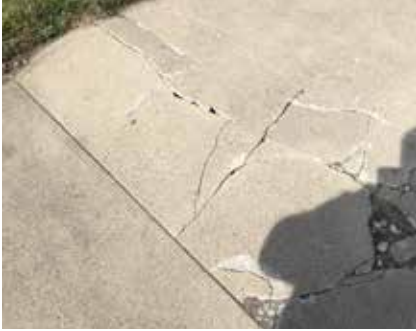
*Cracked concrete panels*

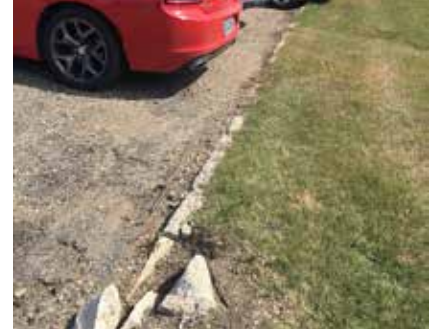
*Damaged curb*

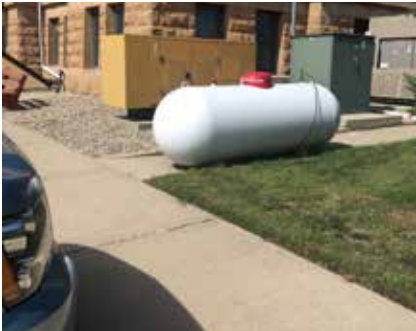
Pedestrian Routes	Sidewalk—East Side of Courthouse	Poor	Propane tank is not guarded with bollards.	Install bollards around propane tank.	\$1,400
Pedestrian Routes	Sidewalk—South Entrance	Fair	Sidewalk panels have settled and the level change exceeds the maximum 1/4" requirement for accessibility.	Replace sidewalk panels at locations with a level change greater than 1/4".	\$2,600

*Mechanical equipment and propane tank*

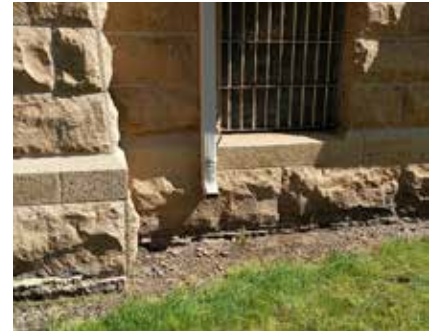
*Downspout west side*

Exterior - Other	High Roof Gutter–Downspout	Poor	2	Original downspout is missing on the east side.	Replace downspout.	\$1,000
Exterior - Other	Downspout–West Side	Fair	2	Downspout does not extend to grade.	Provide downspout extension and/or concrete splash block.	\$200

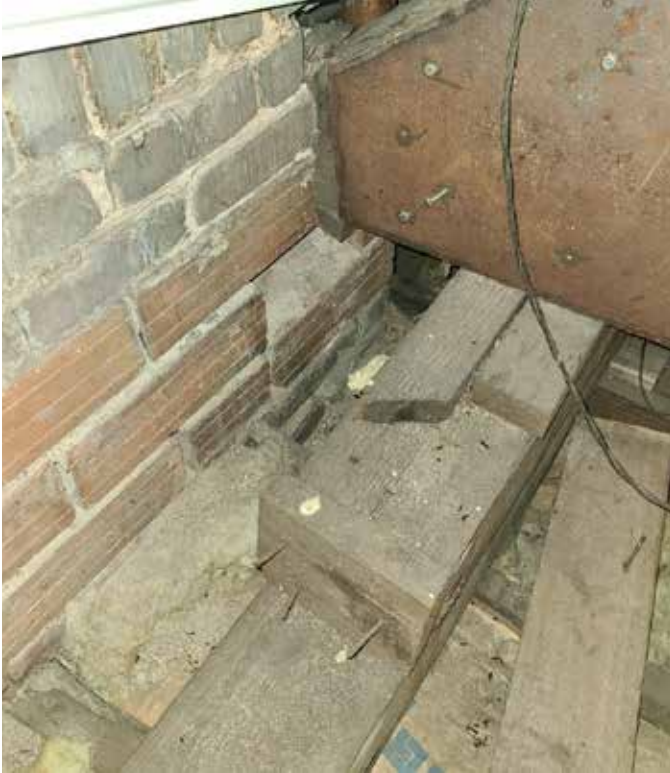
Northeast roof truss bearing—attic

Sub-Category	Element/ Location	Condition	Priority	Details	Recommendation	Estimated Cost
Exterior Roof	Northeast Roof Truss Bearing–Attic	Poor	1	Timber roof truss bearing at exterior masonry wall has been compromised due to extensive water damage at that bearing location. The water infiltration appears to have been corrected, but masonry wall and truss need to be addressed.	Repair timber roof truss bearing using construction documents prepared by a licensed structural engineer.	\$33,300
Exterior Roof	Roof Truss– Attic	Good	3	Typical wood trusses appear to be in good condition. Member are free of rot, bowing, and splitting.	Perform regular inspections.	\$0
Exterior Roof	Roof Framing– Attic	Good	3	Roof framing is in good condition with no visible signs of rot, excessive deflection or bowing. 1x roof decking appears to be in good condition	Perform regular inspections.	\$0
Exterior Roof	Spire Framing –Tower	Fair	3	No rot visible. There is evidence of moisture infiltration in the past. Moisture infiltration appears to have been mitigated.	Perform regular inspections.	\$0

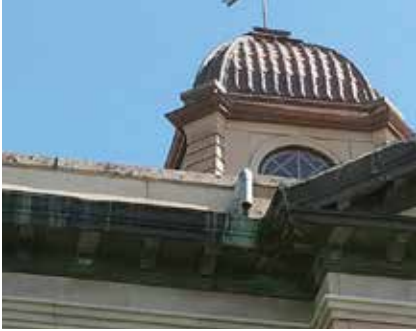
*Dome and high roof gutter downspout*

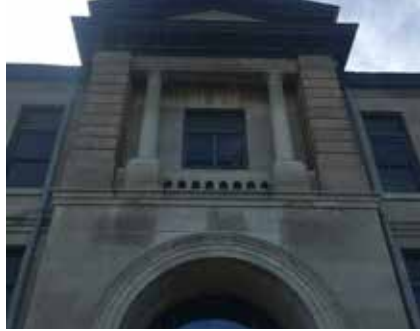
*Roof gutter system*

Exterior Roof	Roof Gutter System and Dome	Poor	1	The roof gutter system is missing corbels and has been patched several times with dissimilar materials. Does not function properly allowing water to run down the face of the building in several locations.	Investigate further as we were not able to access the area. Survey it with ISG drone.	\$2,700

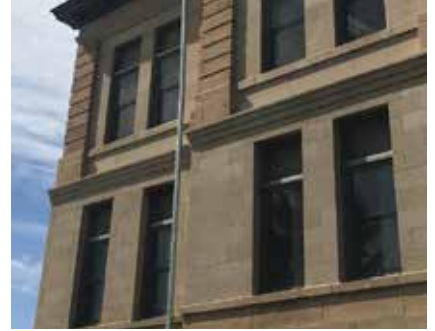
*Roof gutter system*

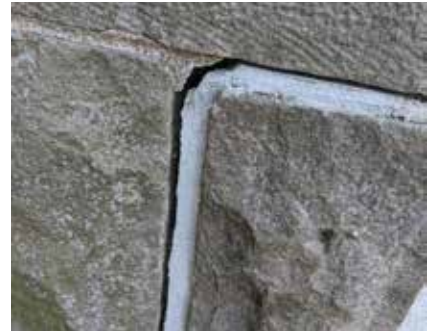
Exterior Walls	Exterior Block	Fair	Caulk is separating from the block.	Perform exterior masonry repairs including tuckpointing.	\$83,200
Exterior Windows	Windows	Good	Windows are drafty and inefficient.	Reseal windows.	\$13,300
Exterior Windows	Windows	Good	Windows drafty and inefficient.	If resealing does not resolve the issue, consider replacing windows with historically consistent, energy efficient insulated windows.	\$164,600
Exterior - Other	High Roof Gutter—Downspout	Poor	Original downspout is missing on the east side.	Replace downspout.	\$1,000
Exterior - Other	Downspout—West Side	Fair	Downspout does not extend to grade.	Provide downspout extension and/or concrete splash block.	\$200

*Exterior block caulk*

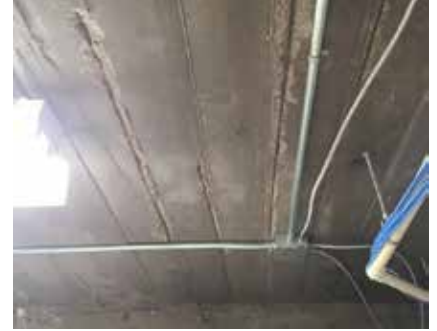
*Ground floor slab*

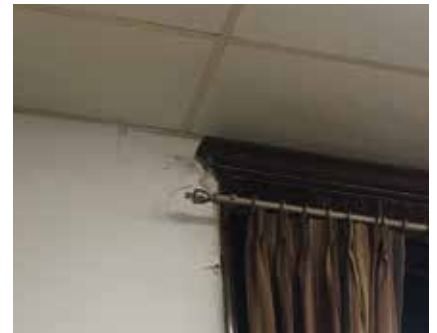
Interior Walls	Courtroom– South Wall	Fair	Wall paint is water damaged and peeling.	Investigate cause of water infiltration and repair.	\$0
Interior Walls	Foundation Wall–Basement Entrance	Fair	Mortar joints are deteriorated in basement wall.	Tuckpoint deteriorated mortar joints.	\$5,400
Interior Walls	Steel Framing– Tower	Good	Steel framing at tower is in good condition. No visible corrosion, bowing, or excessive deflection.	Perform regular inspections.	\$0
Interior Walls	Courtroom– Judge's Seat	Good	Woodwork and mural are in good condition.	Perform routine maintenance and refinish when needed.	\$0
Interior Walls	Breakroom	Fair	Wood paneling is dated and shows signs of wear, especially around the sink.	Remove wood paneling, install tile around sink, and repaint remainder of walls.	\$2,100

*Courtroom—south wall*

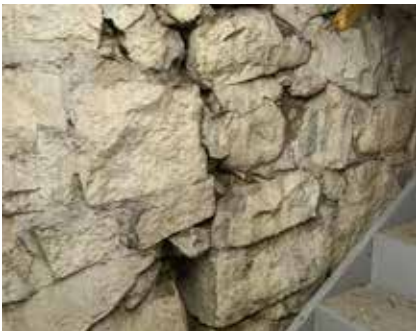
*Foundation wall—basement entrance*

Interior Walls	Courtroom– South Wall	Fair	1	Wall paint is water damaged and peeling.	Investigate cause of water infiltration and repair.	\$0
Interior Walls	Foundation Wall–Exterior Basement Entrance	Fair	2	Mortar joints are deteriorated in basement wall.	Tuckpoint deteriorated mortar joints.	\$5,400
Interior Walls	Steel Framing– Tower	Good	3	Steel framing at tower is in good condition. No visible corrosion, bowing, or excessive deflection.	Perform regular inspections.	\$0
Interior Walls	Courtroom– Judge's Seat	Good	3	Woodwork and mural are in good condition.	Perform routine maintenance and refinish when needed.	\$0

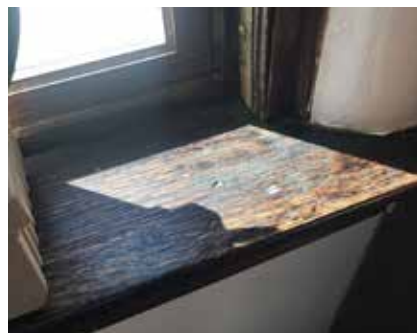
*Interior window and sill*

Sub Category	Element/Location	Condition	Details	Recommendation	Estimated Cost
Interior Windows	Interior window sills	Fair	Window sills and frames are showing signs of water and sun damage.	Refinish select window sills and frames.	\$10,000
Interior Doors	Door Knobs	Good	Door knobs are not accessible.	Review with historic preservation guidelines and consider replacing with lever.	\$9,000

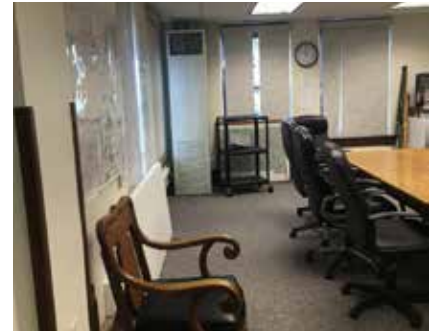
*Carpeted floors—Planning and Zoning office*

Sub-Category	Element/ Location	Condition	Priority	Details	Recommendation	Estimated Cost
Interior Floors	Flooring— Planning and Zoning Office	Fair	2	Flooring	Replace flooring with carpet.	\$1,800
Interior Floors	Auditor's Vault	Poor	3	Carpet shows signs of wear and deterioration.	Replace carpet.	\$1,800
Interior Floors	County Commission Room	Poor	3	Carpet is bubbling up in a few locations, is worn and has surpassed its useful service life.	Replace carpet.	\$2,800
Interior Floors	General	Good	3	Consider replacing carpet with carpet tile for ease of future replacement and maintenance.	Perform regular maintenance and replace carpet as needed. (5-7 years)	\$35,000
Interior Casework	County Offices	Fair	1	Work are lacks accessible counter and work surface.	Replace counter with a bi-level counter.	\$12,000
Interior Casework	Planning and Zoning Office	Poor	2	Casework showing signs of wear.	Replace cabinetry.	\$2,400

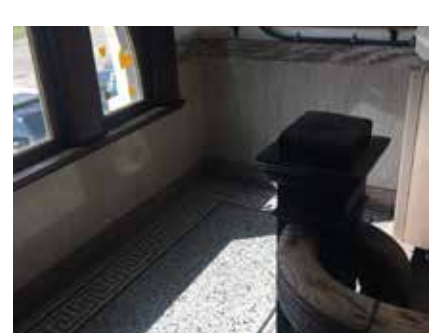
*Wood handrail*

Sub-Category	Element/ Location	Condition	Priority	Details	Recommendation	Estimated Cost
Interior - Other	Wood Handrails	Fair	2	Wood finish is wearing off, leaving the wood railing susceptible to increased deterioration.	Refinish wood hand railings.	\$300
Interior - Other	Restroom—Jury Room	Good	3	Missing wood trim at wall access below lavatory.	Replace wood trim at access panel.	\$100
Interior - Other	Courtroom	Good	1	Witness stand is not accessible.	Remodel jury stand to provide an accessible witness stand.	\$700
Interior - Other	Courtroom	Fair	1	Jury box is not accessible.	Remodel jury box and provide accessible seating option.	\$5,700
Interior - Other	Vertical Circulation	Poor	1	Building only has one way to third floor.	Install an elevator to meet requirements as a secondary exit.	\$470,000

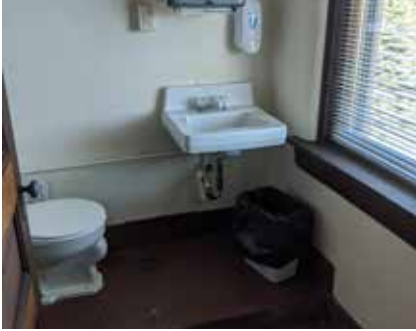
Sub Category	Element/Location	Condition	Details	Recommendation	Estimated Cost
Interior - Other	Women's Restroom— Third Floor	Fair	Restroom stall is located on a raised platform and not accessible.	Install a portable ramp accessible stall. Remodel restroom so it is accessible.  *Will require further investigation to understand floor structure and existing conditions.	\$10,700
Interior - Other	Restroom—Judge's	Fair	Restroom stall is located on a raised platform and not accessible.	Remodel restroom so it is accessible.  *Will require further investigation to understand floor structure and existing conditions.	\$6,700
Interior - Other	Restroom— Jury Room	Good	Restroom lacks signage.	Install a restrooms sign with accessibility symbol.	\$200
Interior - Other	Restroom— Jury Room	Good	Missing wood trim at wall access below lavatory.	Replace wood trim at access panel.	\$100
Other - Plumbing	Drinking Fountain	Fair	Drinking fountain is not accessible.	Replace drinking fountain with bi-level accessible fountain.	\$900

Restroom fixtures and step

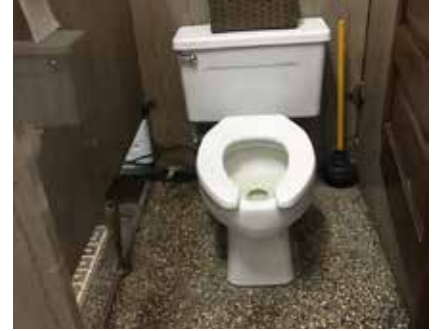
Women's restroom

Interior - Other	Women's Restroom— Third Floor	Fair	1	Restroom stall is located on a raised platform and not accessible.	Remodel restroom so it is accessible.  *Will require further investigation to understand floor structure and existing conditions.	\$10,700
Interior - Other	Restroom— Judge's	Fair	1	Restroom stall is located on a raised platform and not accessible.	Remodel restroom so it is accessible.  *Will require further investigation to understand floor structure and existing conditions..	\$6,700
Interior - Other	Restroom—Jury Room	Good	3	Restroom lacks signage.	Install a restrooms sign with accessibility symbol.	\$200

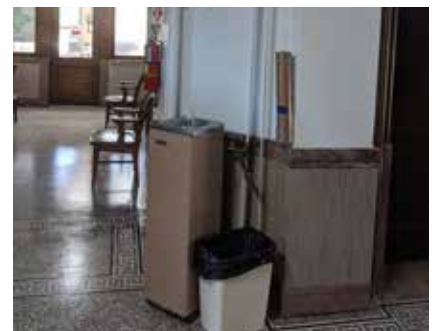
Water fountain

Other - Plumbing	Drinking Fountain	Fair	Drinking fountain is not accessible.	Replace drinking fountain with bi-level accessible fountain.	\$900

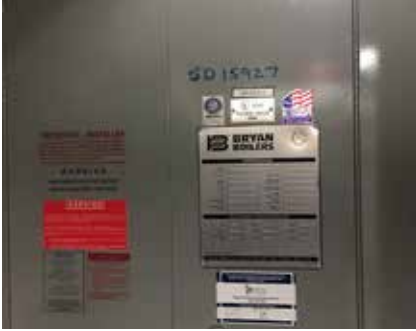
Boiler

Sub-Category	Element/ Location	Condition	Priority	Details	Recommendation	Estimated Cost
Heating/ Cooling	Bryan Electric Boiler	Fair	2	Boiler was built in 2007. Evaluate switching out the electric boiler with a gas fired boiler.	Replace electric boiler with a gas fired boiler. (Price is included in HVAC replacement cost.)	\$70,000
Heating/ Cooling	HVAC Units	Poor	1	HVAC units were installed in 2007. It is a 2-pipe system. Controls were installed at the same time. System does not provide dehumidification. System does not supply code required fresh air.	Replace HVAC system.	\$1,630,000
Heating/ Cooling	York Chiller	Fair	2	A York Chiller was installed in 2007 and contains R22 refrigerant. The refrigerant is no longer available.	Replace with 50 ton chiller. (Price is included in HVAC replacement cost.)	\$150,000
Restrooms	Women's Restroom— First Floor	Fair	1	Lavatory and vanity are not accessible.	Replace the lavatory and vanity.	\$700

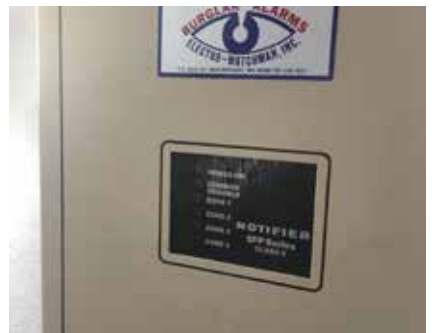
Sub Category	Element/Location	Condition	Details	Recommendation	Estimated Cost
Power Supply	Electrical Panels	Good	The power supply was updated in 2007.	Perform regular maintenance.	\$0
Power Supply	Outlets	Good	Outlets were added in 2007 with the addition of a wiremold raceway.	Perform regular maintenance.	\$0
Exterior Lighting	Exterior Lighting	Poor	Exterior lighting is outdated and inefficient.	Install LED lighting and controls.	\$128,100
Interior Lighting	Interior Lighting	Poor	Existing lighting is florescent tubes.	Install LED lighting and controls.	\$1,000
Life Safety	On-Site Generator	Good	LP fuel tank is an Olympian G75FIS.	Perform regular maintenance.	\$0
Life Safety	Fire Alarm	Poor	Fire alarm system has reached the end of its useful service life.	Replace fire alarm panel.	\$81,500

Fire alarm
