# Marshall County Courthouse Facility Assessment

November 6, 2020

Josh Muckenhirn, AIA  
*Architect*  
ISG  
101 South Reid Street + Suite 202  
Sioux Falls, SD 57103  
605.274.6401  
Josh.Muckenhirn@ISGInc.com

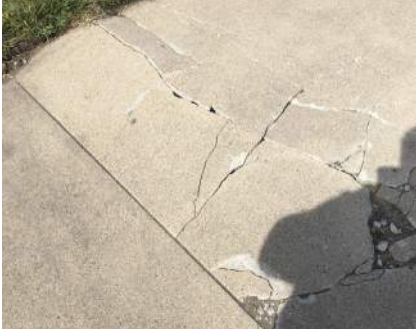
*Cracked concrete panels*

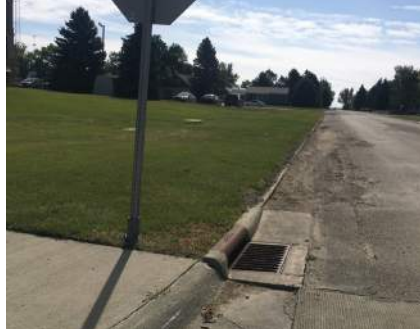
*Site drainage*

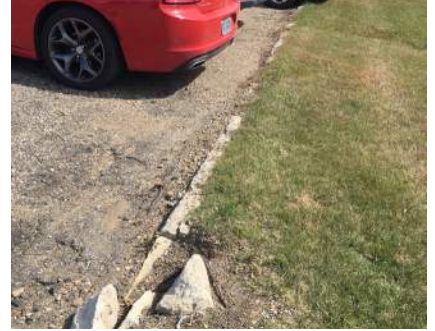
*Damaged curb*

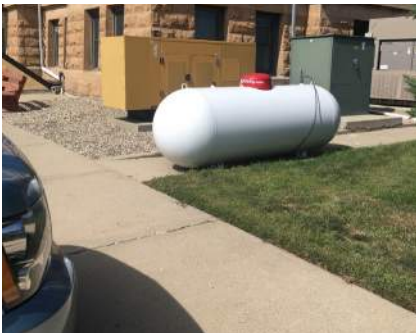
Pedestrian Routes	Sidewalk—East Side of Courthouse	Poor	Propane tank is not guarded with bollards.	Install bollards around propane tank.	\$1,400
Pedestrian Routes	Sidewalk—South Entrance	Fair	Sidewalk panels have settled and the level change exceeds the maximum 1/4" requirement for accessibility.	Replace sidewalk panels at locations with a level change greater than 1/4".	\$2,600

*Mechanical equipment and propane tank*

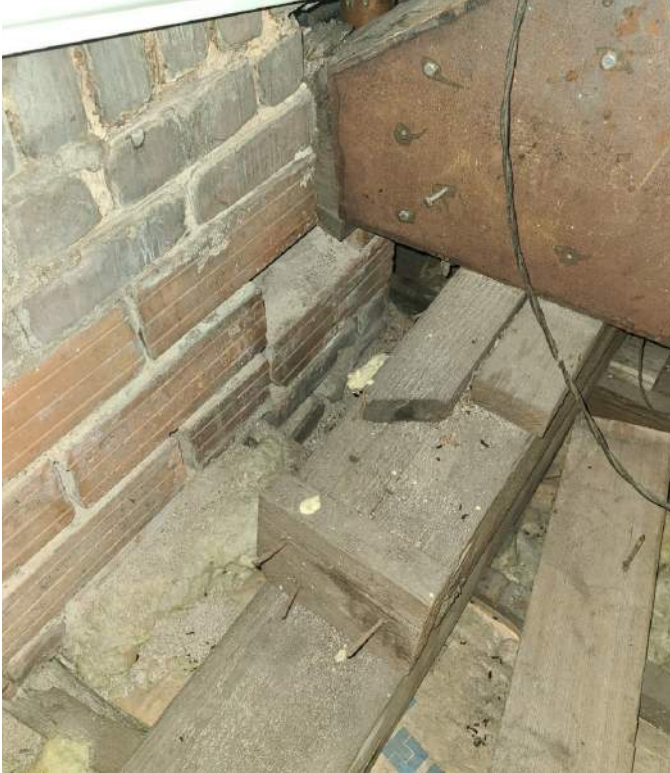
Sub Category	Element/Location	Condition	Details	Recommendation	Estimated Cost
Exterior Roof	Northeast Roof Truss Bearing–Attic	Poor	Timber roof truss bearing at exterior masonry wall has been compromised due to extensive water damage at that bearing location. The water infiltration appears to have been corrected, but masonry wall and truss need to be addressed.	Repair timber roof truss bearing using construction documents prepared by a licensed structural engineer.	\$33,300
Exterior Roof	Roof Truss–Attic	Good	Typical wood trusses appear to be in good condition. Member are free of rot, bowing, and splitting.	Perform regular inspections.	\$0
Exterior Roof	Roof Framing–Attic	Good	Roof framing is in good condition with no visible signs of rot, excessive deflection or bowing. 1x roof decking appears to be in good condition	Perform regular inspections.	\$0
Exterior Roof	Spire Framing –Tower	Fair	No rot visible. There is evidence of moisture infiltration in the past. Moisture infiltration appears to have been mitigated.	Perform regular inspections.	\$0

*Northeast roof truss bearing—attic*

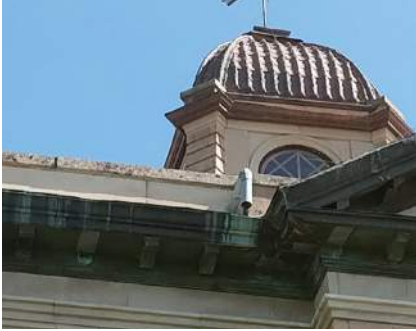
*Dome and high roof gutter downspout*

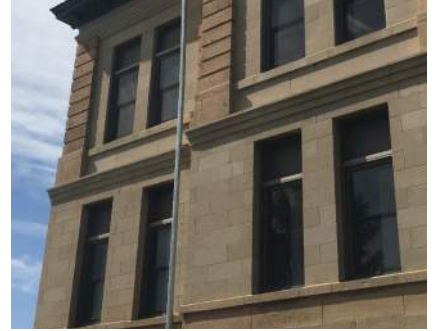
*Gutter system*

Exterior Roof	Roof Gutter System and Dome	Poor	The roof gutter system is missing corbels and has been patched several times with dissimilar materials. Does not function properly allowing water to run down the face of the building in several locations.	Investigate further as we were not able to access the area. Survey it with ISG drone.	\$2,700
Exterior Roof	Roof Gutter System	Poor	The roof gutter system is missing corbels and has been patched several times with dissimilar materials. It does not function properly resulting in water running down the face of the building in several locations.	Replace roof copper gutter system.	\$800,000

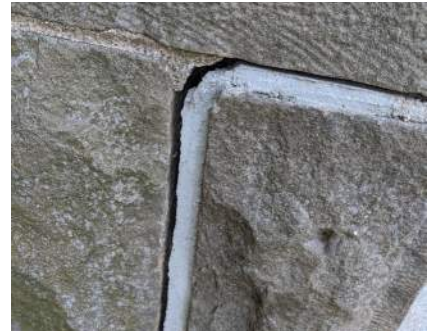
*Exterior block caulk*

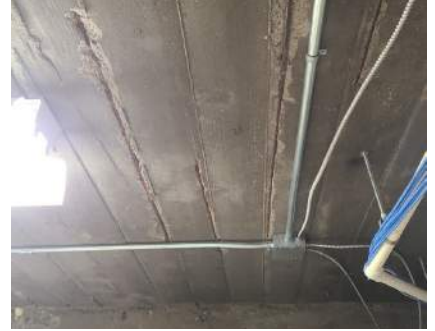
*Ground floor slab*

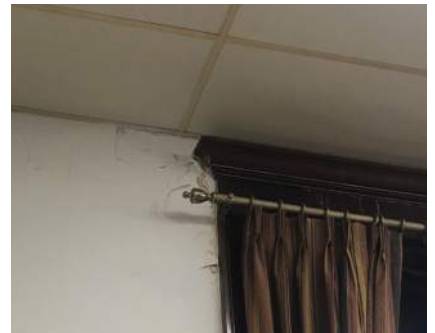
*Courtroom-south wall*

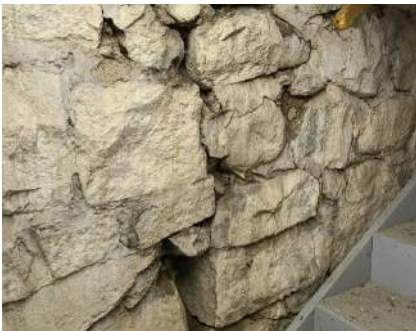
*Foundation wall-basement entrance*

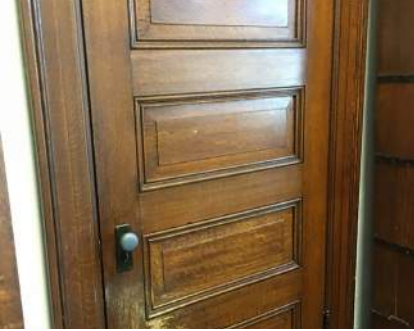
*Door panels*

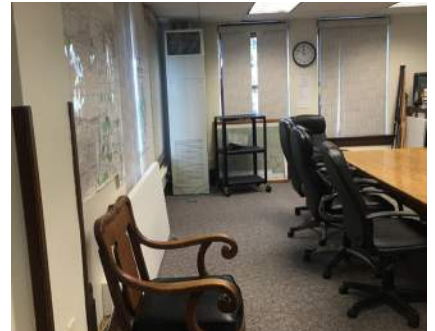
*Carpeted floors—Planning and Zoning office*

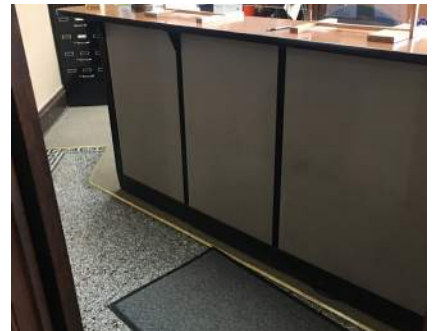
*Interior casework—County offices*

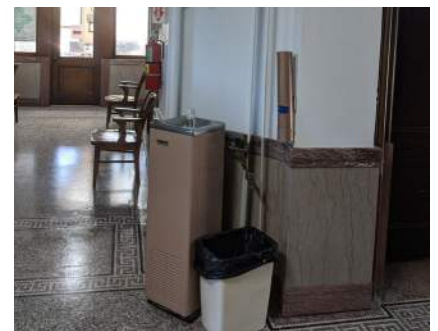
*Water fountain*

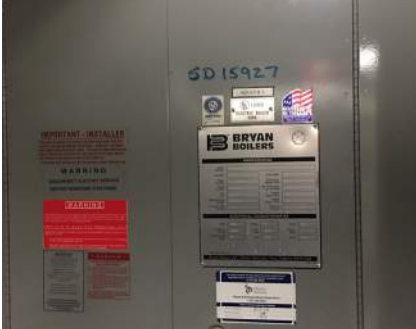
Boiler

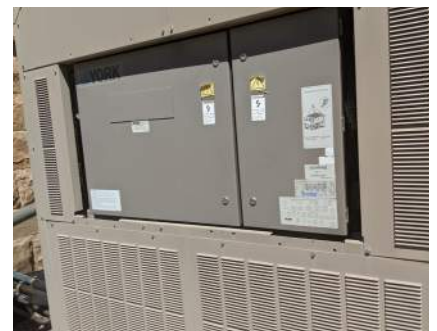
Chiller

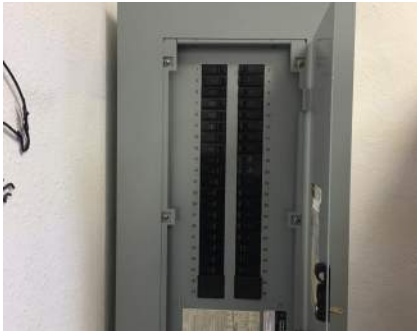
Electric panelboard
