## GEOTEK ENGINEERING & TESTING SERVICES, INC.

Subj: Asbestos Survey

Targeted Brownfield Assessment Marshall County Courthouse

DANR #4444.003 GeoTek #24-1420

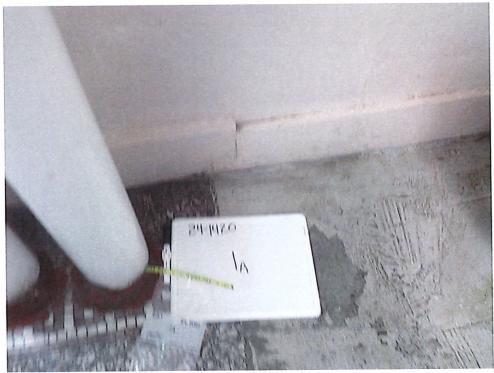
Sample 1A – Plaster

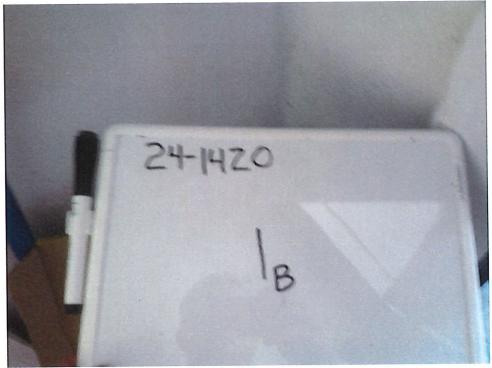
Sample 1B – Plaster

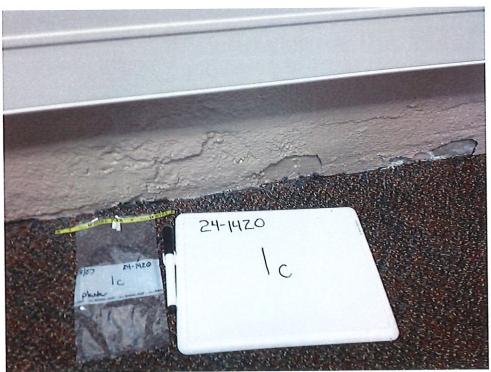
Sample 1C – Plaster

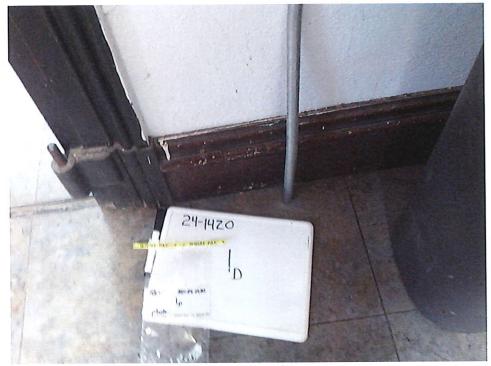
Sample 1D – Plaster

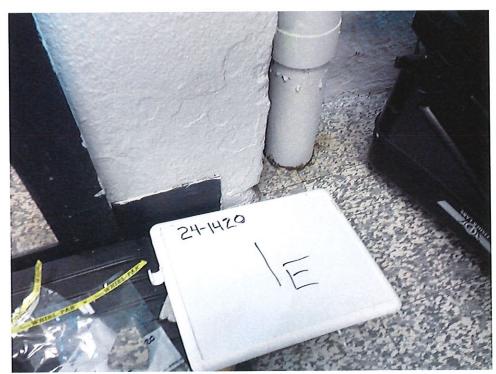
Sample 1E – Plaster

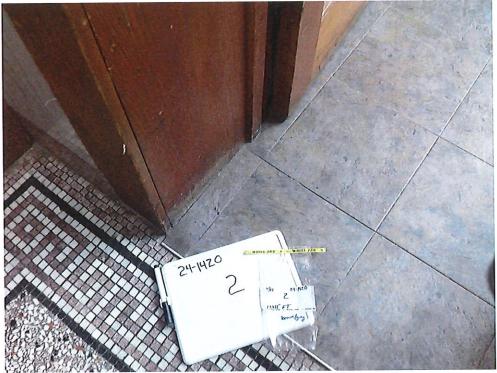
Sample #2 – 12x12" Floor Tile (N. Sheriff's Office)

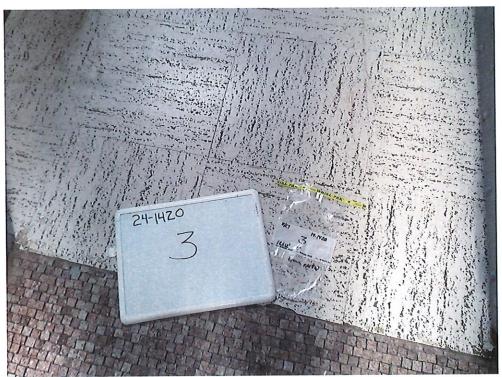
~ min pro-	(1708001	, ,					
Material	Location	Sample Numbers	Friable	Estimated Quantity	Comments				
Category I Non-Friable ACM									
12x12" Floor tile (cream)	Sheriff's Office	3	No	$\approx 490 \text{ ft}^2$	2% Chrysotile (tile only)				
9x9" Floor tile (gray)	Register's Vault	5	No	$\approx 266 \text{ ft}^2$	3% Chrysotile (tile only)				
9x9" Floor tile (gray)	Commissioner's Vault	6	No	$\approx 266 \text{ ft}^2$	3% Chrysotile (tile only)				
9x9" Floor tile (olive green)	Court Storage Rm & Judge's chamber		No	$\approx 256 \text{ ft}^2$	2% Chrysotile (tile only)

Sample #3 – 12x12" Floor Tile (W. Sheriff's Office)
(Asbestos Containing Material)

If any of the listed asbestos containing materials will likely be disturbed by future renovation activities, it should be abated by a licensed SD asbestos abatement contractor prior to renovation. The asbestos containing floor tiles may remain in place if the client so chooses as long as care is taken during renovation activities not to disturb it.

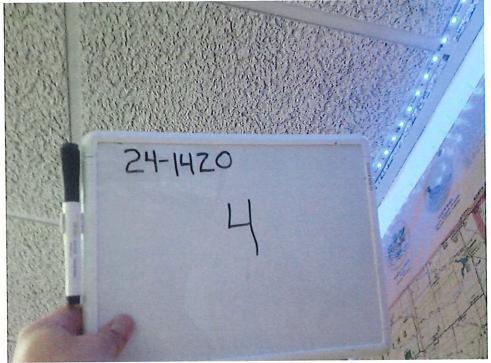
Sample #4 – 2x2' Ceiling Tile (911 Office)

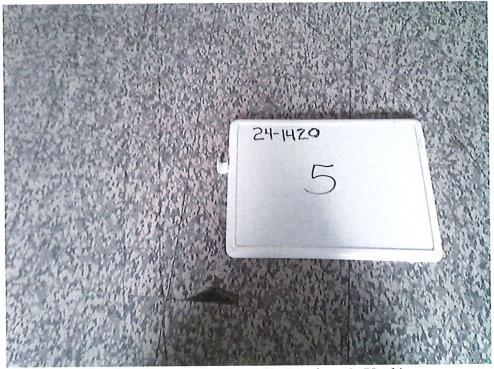
Sample #5 – 9x9" Floor Tile (Registrar's Vault) (Asbestos Containing Material)

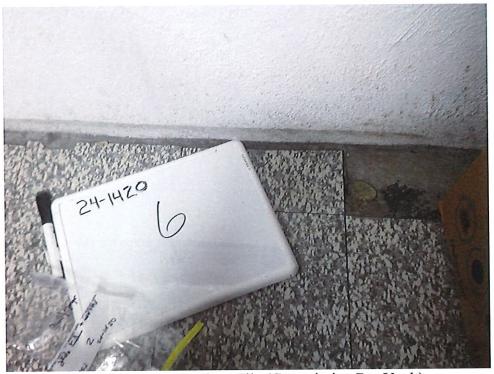
Sample #6 – 9x9" Floor Tile (Commission Rm Vault)
(Asbestos Containing Material)

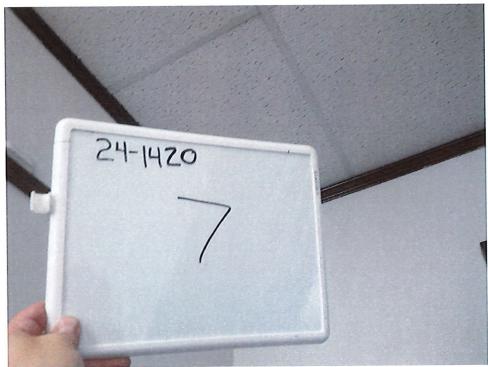
Sample #7 – 2x4' Ceiling Tile (3<sup>rd</sup> Floor)

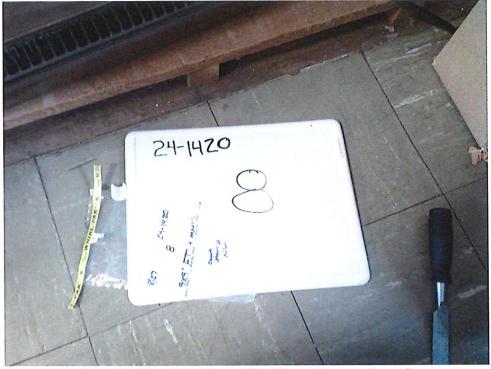
Sample #8 – 9x9" Floor Tile (Court Storage Room)
(Asbestos Containing Material)

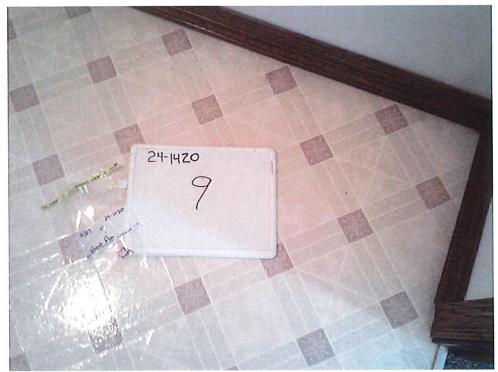
Sample #9 – Sheet Flooring (Jury Room Bath)

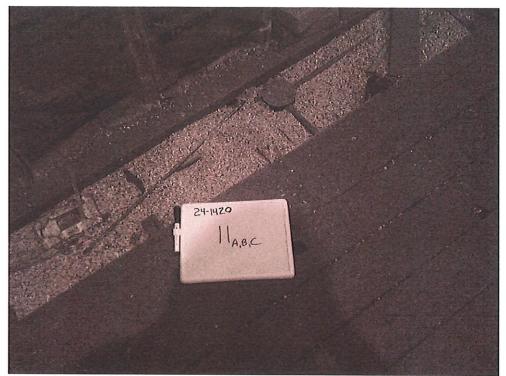
Three samples of loose vermiculite insulation were also sampled from the attic space. All three samples were analyzed using point count methodology and found to contain <1% asbestos (0.7%, 0.4% & 0.4%). This material is therefore not considered to be an "asbestos containing

Samples 11A-C – Vermiculite Insulation – Attic Spaces

material" for the purposes of abatement or disposal. For the minor (0.7 to 0.4%) asbestos content in the vermiculite insulation, precautions such as respiratory protection, wetting material, etc., are recommended and appropriate when people are disturbing or handling an (non-NESHAPS regulated) asbestos containing material, and employees would still be subject to OSHA asbestos rules. While abatement (removal) of the vermiculite would help reduce the risk of future exposure, there is no rule requirement mandating removal or special disposal. However, if removal of the vermiculite is desired by parties involved, we would recommend having it done by a licensed asbestos abatement firm.

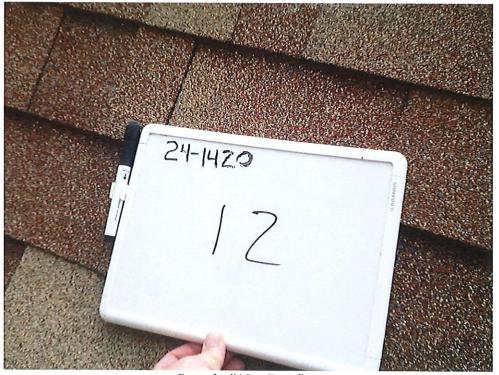
Sample #12 – Roofing
