## GEOTEK ENGINEERING & TESTING SERVICES, INC.

Subj: Asbestos Survey

Targeted Brownfield Assessment Marshall County Courthouse

DANR #4444.003 GeoTek #24-1420

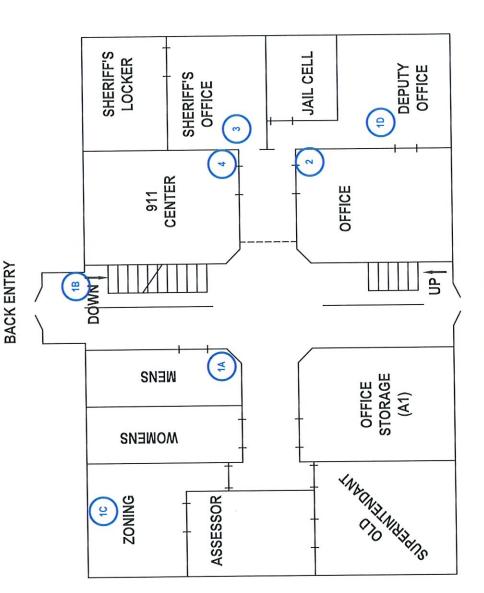
FIGURE 3A

PROJECT#: 24-1420 DRAWN BY: MW ACAD/GEOTEK/JASON/24-1420 FIRST FLOOR SAMPLE LOCATIONS
MARSHALL COUNTY COURTHOUSE
911 VANDERHORCK STREET
BRITTON, SD
