# Marshall County Courthouse Facility Assessment

October 09, 2020

Josh Muckenhirn, AIA  
*Architect*  
ISG  
101 South Reid Street + Suite 202  
Sioux Falls, SD 57103  
605.274.6401  
Josh.Muckenhirn@ISGInc.com

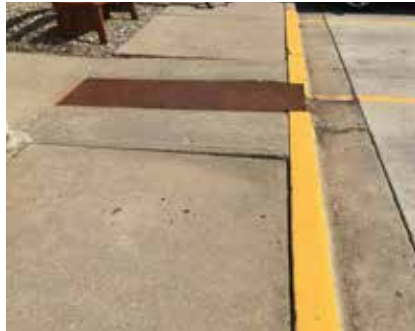
*Pedestrian route*

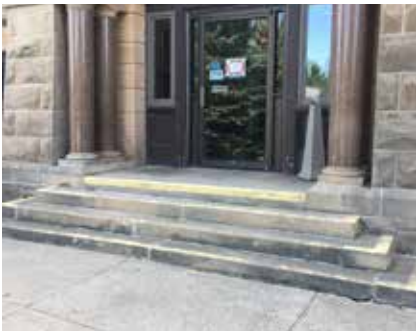
*Main historic entrance—north side*

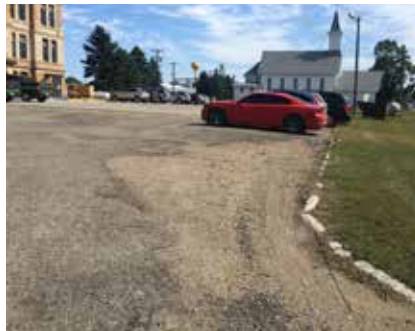
*Parking*

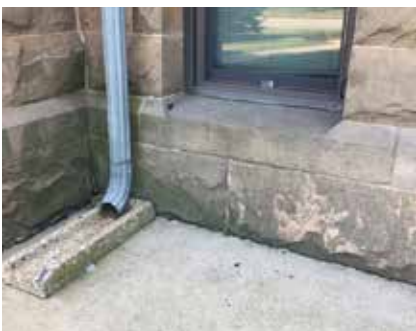
*Roof drainage*

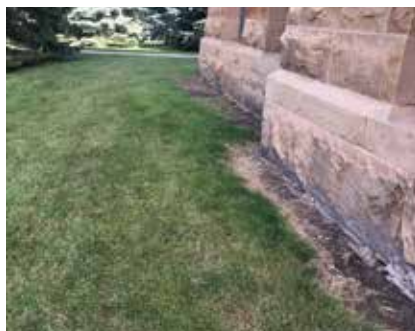
*Site drainage*

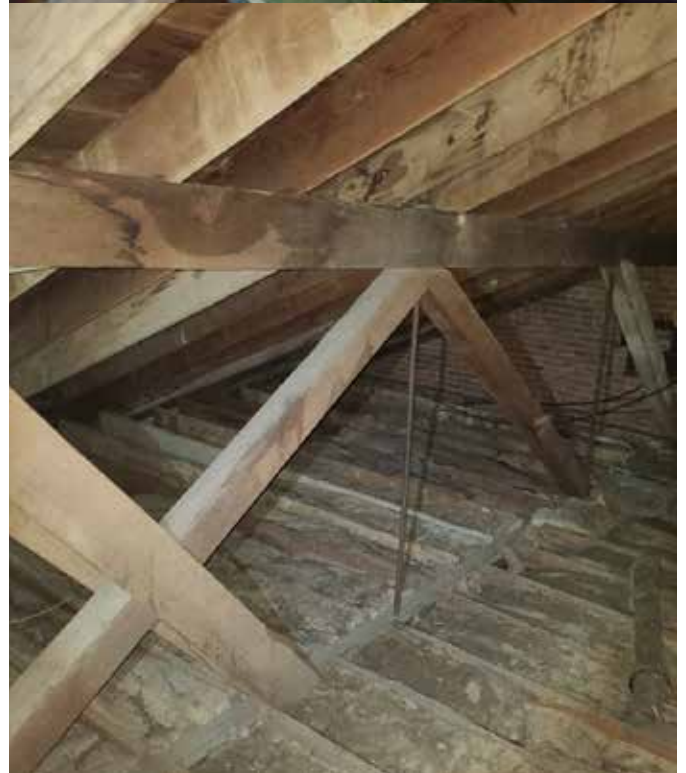
Roof truss—attic

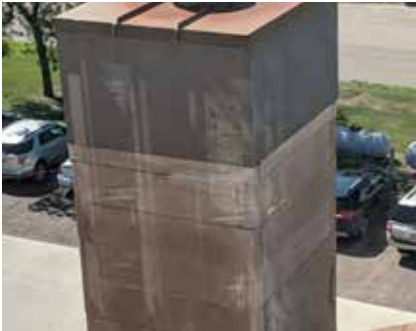
*Chimney*

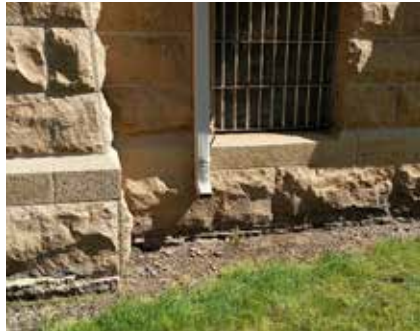
Exterior Walls	Exterior Block	Fair	Caulk is separating from the block.	Perform exterior masonry repairs including tuckpointing.	\$83,200
Exterior Windows	Windows	Good	Windows are drafty and inefficient.	Reseal windows.	\$13,300
Exterior Windows	Windows	Good	Windows drafty and inefficient.	If resealing does not resolve the issue, consider replacing windows with historically consistent, energy efficient insulated windows.	\$164,600
Exterior - Other	High Roof Gutter—Downspout	Poor	Original downspout is missing on the east side.	Replace downspout.	\$1,000
Exterior - Other	Downspout—West Side	Fair	Downspout does not extend to grade.	Provide downspout extension and/or concrete splash block.	\$200

*Exterior block-north wall*

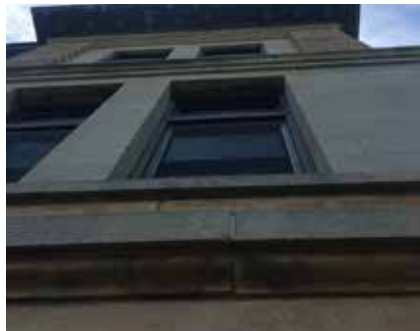
*Building exterior masonry*

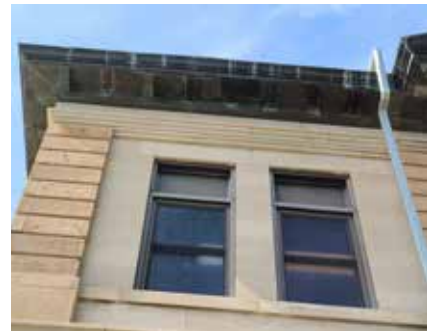
Sub Category	Element/Location	Condition	Details	Recommendation	Estimated Cost
Exterior Roof	Roof Gutter System and Dome	Poor	The roof gutter system is missing corbels and has been patched several times with dissimilar materials. Does not function properly allowing water to run down the face of the building in several locations.	Investigate further as we were not able to access the area. Survey it with ISG drone.	\$2,700
Exterior Roof	Roof Gutter System	Poor	The roof gutter system is missing corbels and has been patched several times with dissimilar materials. It does not function properly resulting in water running down the face of the building in several locations.	Replace roof copper gutter system.	\$800,000
Exterior Walls	Chimney	Fair	Masonry joints are deteriorating.	Tuckpoint the chimney walls.	\$2,500
Exterior Walls	Exterior Block—North Wall	Fair	Block is shifting away from building but poses no structural concern.	Perform regular inspections.	\$0

*Exterior windows and roof gutter*

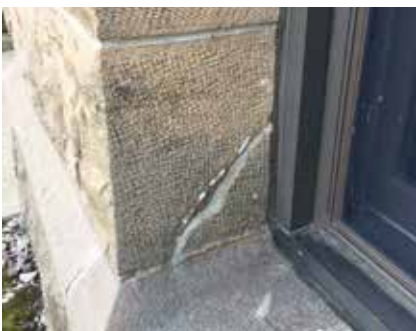
*Exterior window*

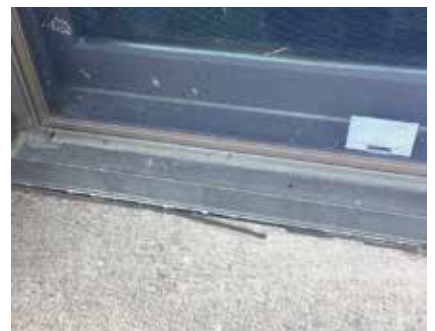
*Exterior window*

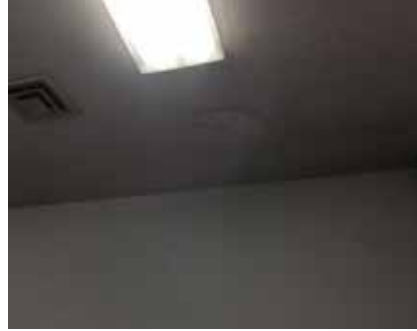
Sub Category	Element/Location	Condition	Details	Recommendation	Estimated Cost
Interior Ceiling	Clerk of Courts	Good	There are water stains on the ceiling around the light fixture and near the wall.	Investigate cause of water infiltration and repair.	\$0
Interior Ceiling	Ground Floor Slab– Basement	Fair	Reinforcing bars in elevated concrete slab supporting the ground floor are exposed to the basement below and are therefore susceptible to corrosion.	Grout the exposed reinforcing bars.	\$6,700
Interior Ceiling	Ceiling Framing–Attic	Good	Ceiling framing is in good condition. Some members appeared to be slightly bowing but do not appear to be of structural concern.	Perform regular inspections.	\$0
Interior Ceiling	Courtroom	Good	The original ceiling is covered with ACT ceiling and grid.	Remove ACT ceiling and grid. Refinish and restore original ceiling.	\$19,200
Interior Walls	Law Library– Third Floor	Fair	Wall paint is water damaged and peeling.	Investigate cause of water infiltration and repair.	\$0

*Interior ceiling*

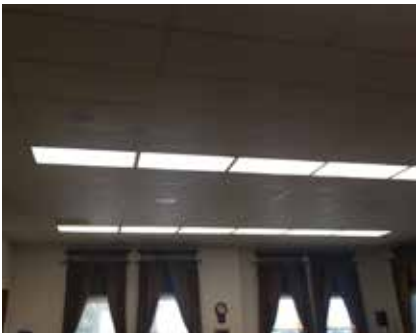
*Courtroom ceiling*

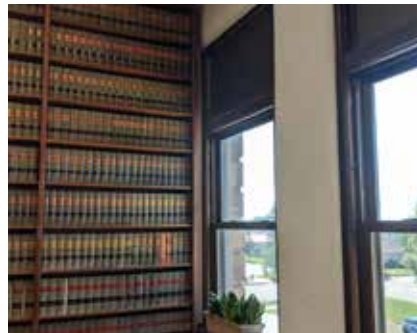
*Law library—third floor interior walls*

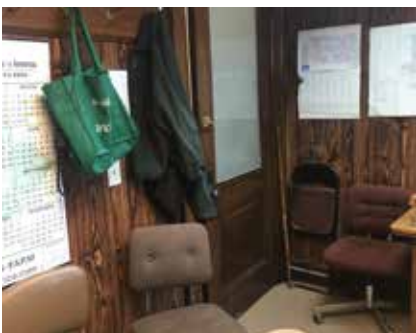
*Breakroom*

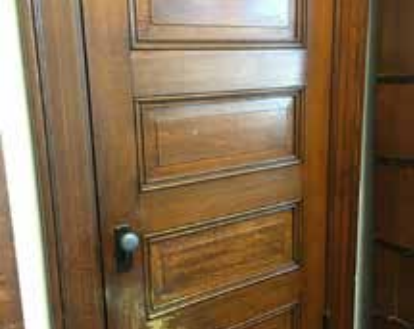
*Door panels*

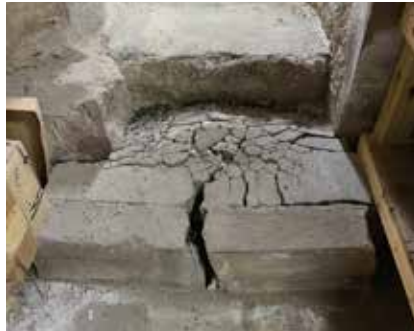
*Concrete step—basement*

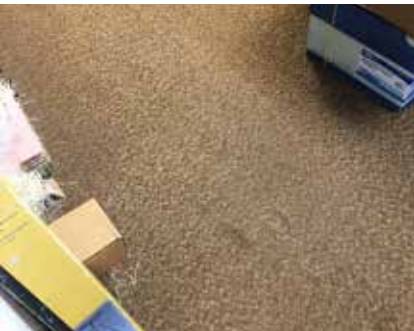
*Carpeted flooring—Auditors' vault*

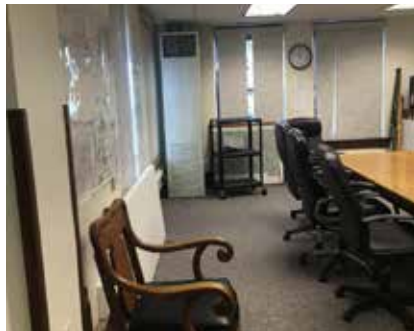
*Carpeted flooring—County Commission room*

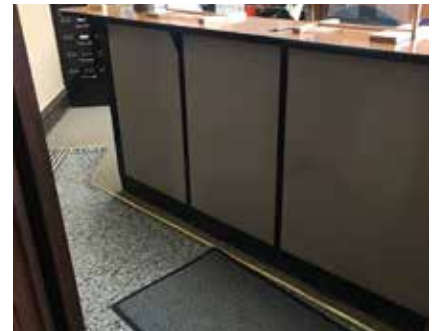
*Interior casework—County offices*
