# Marshall County Courthouse Facility Assessment

November 6, 2020

Josh Muckenhirn, AIA  
*Architect*  
ISG  
101 South Reid Street + Suite 202  
Sioux Falls, SD 57103  
605.274.6401  
Josh.Muckenhirn@ISGInc.com

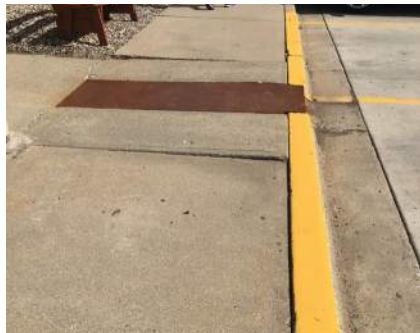
*Pedestrian route*

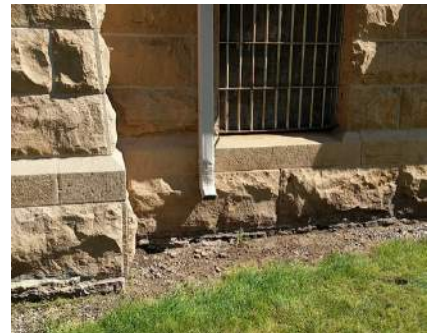
*Downspout west side*

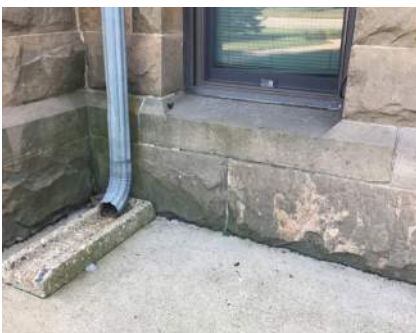
*Roof drainage*

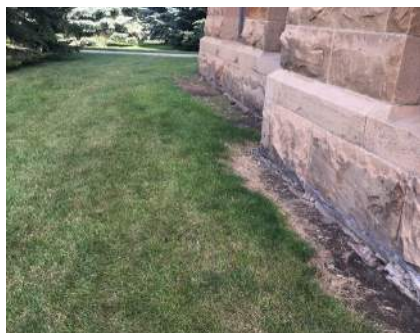
Sub Category	Element/Location	Condition	Details	Recommendation	Estimated Cost
Drainage	Building Perimeter	Poor	Areas around the building slope towards the building.	Regrade and seed/sod select locations to get the water to drain away from the building.	\$20,000
Grounds/Turf	Site Curbing—Property West Side	Poor	Curb is damaged and in various stages of deterioration.	Replace curb.	\$14,100
Vehicle Routes	Parking Lot Curb	Poor	Curb is damaged and in various stages of deterioration. This is causing gravel from the parking lot to erode into the grass and damage the grass.	Replace curb.	\$11,500
Vehicle Routes	Asphalt Parking Lot	Fair	Asphalt paving is deteriorating.	Replace asphalt pavement with concrete.	*\$58,400
Pedestrian Routes	Sidewalk Approach—Building North Side	Fair	Sidewalk is cracking.	Replace damaged concrete panels.	\$2,200
Pedestrian Routes	Sidewalk—East Side of Courthouse	Good	Propane tank is blocking the pedestrian route.	Create a pad adjacent to the sidewalk for the tank to sit on.	*\$3,400

*Site drainage*

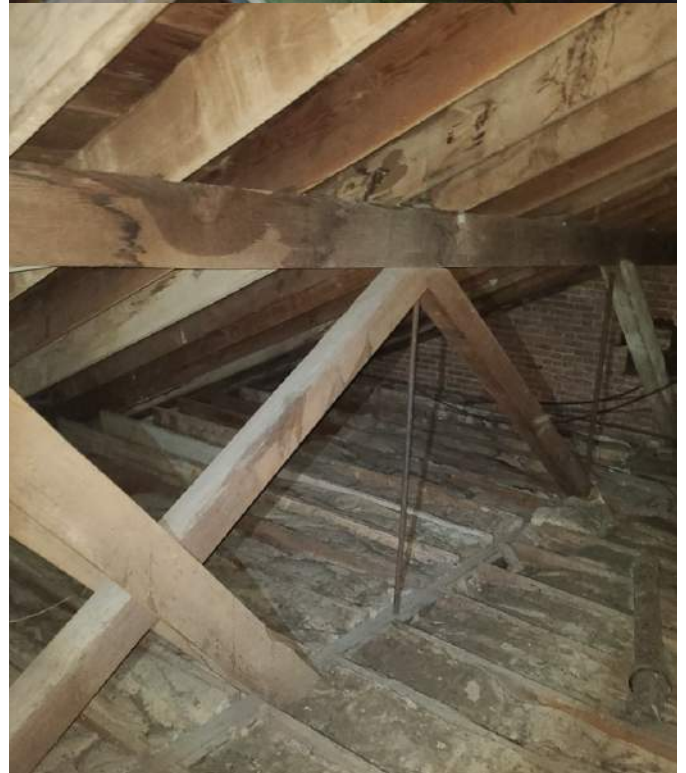
*Roof truss—attic*

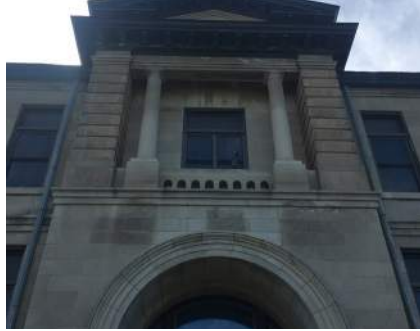
Sub Category	Element/Location	Condition	Details	Recommendation	Estimated Cost
Exterior Roof	Roof Gutter System and Dome	Poor	The roof gutter system is missing corbels and has been patched several times with dissimilar materials. Does not function properly allowing water to run down the face of the building in several locations.	Investigate further as we were not able to access the area. Survey it with ISG drone.	\$2,700
Exterior Roof	Roof Gutter System	Poor	The roof gutter system is missing corbels and has been patched several times with dissimilar materials. It does not function properly resulting in water running down the face of the building in several locations.	Replace roof copper gutter system.	\$800,000
Exterior Walls	Chimney	Fair	Masonry joints are deteriorating.	Tuckpoint the chimney walls.	\$2,500
Exterior Walls	Exterior Block—North Wall	Fair	Block is shifting away from building but poses no structural concern.	Perform regular inspections.	\$0

*Roof gutter system*

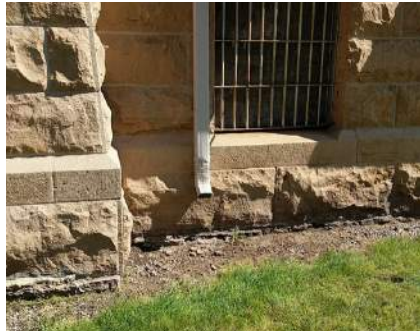
Exterior Walls	Exterior Block	Fair	Caulk is separating from the block.	Perform exterior masonry repairs including tuckpointing.	\$83,200
Exterior Windows	Windows	Good	Windows drafty and inefficient.	Replace windows with historically consistent, energy efficient insulated windows.	\$164,600
Exterior - Other	High Roof Gutter—Downspout	Poor	Original downspout is missing on the east side.	Replace downspout.	\$1,000
Exterior - Other	Downspout—West Side	Fair	Downspout does not extend to grade.	Provide downspout extension and/or concrete splash block.	\$200

*Exterior block-north wall*

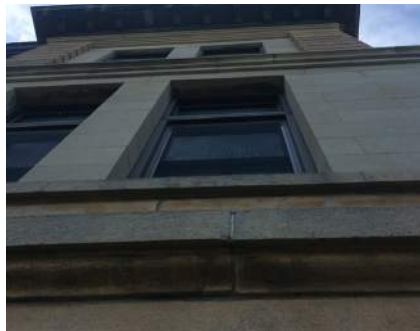
*Building exterior masonry*

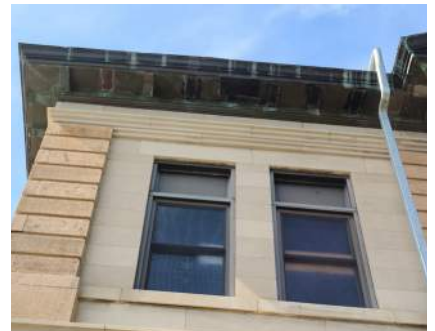
*Exterior windows and roof gutter*

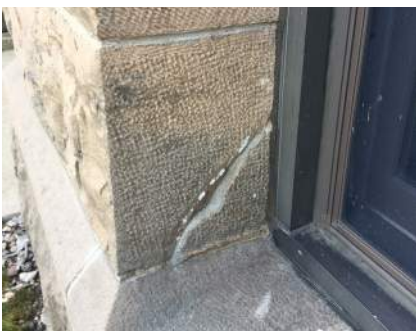
*Exterior window*

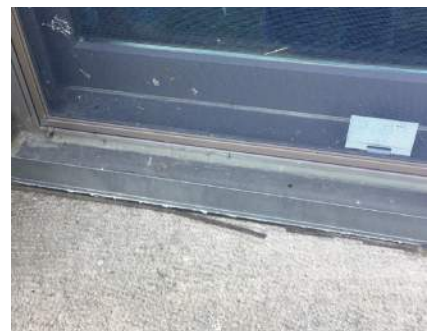
*Exterior window*

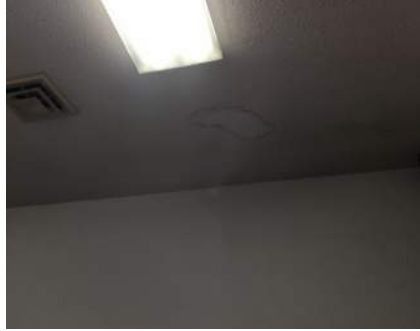
Sub Category	Element/Location	Condition	Details	Recommendation	Estimated Cost
Interior Ceiling	Clerk of Courts	Good	There are water stains on the ceiling around the light fixture and near the wall.	Investigate cause of water infiltration and repair.	\$0
Interior Ceiling	Ground Floor Slab– Basement	Fair	Reinforcing bars in elevated concrete slab supporting the ground floor are exposed to the basement below and are therefore susceptible to corrosion.	Grout the exposed reinforcing bars.	\$6,700
Interior Ceiling	Ceiling Framing–Attic	Good	Ceiling framing is in good condition. Some members appeared to be slightly bowing but do not appear to be of structural concern.	Perform regular inspections.	\$0
Interior Ceiling	Courtroom	Good	The original ceiling is covered with ACT ceiling and grid.	Remove ACT ceiling and grid. Refinish and restore original ceiling.	\$19,200
Interior Walls	Law Library– Third Floor	Fair	Wall paint is water damaged and peeling.	Investigate cause of water infiltration and repair.	\$0

*Interior ceiling*

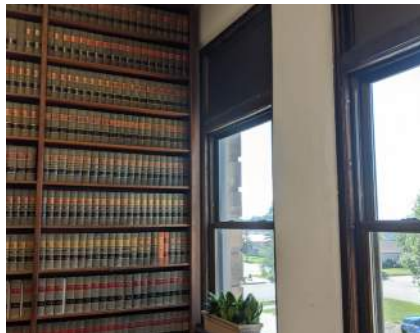
*Law library-third floor interior walls*

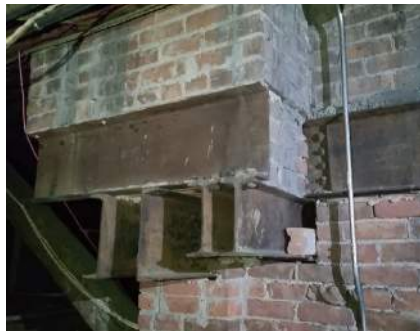
*Steel framing tour*

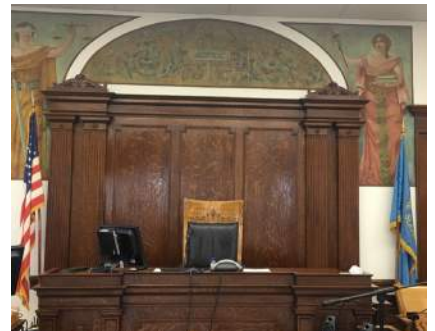
*Courtroom judge's bench*

Sub Category	Element/Location	Condition	Details	Recommendation	Estimated Cost
Interior Walls	Courtroom—Judge's Seat	Good	Woodwork and mural are in good condition.	Perform routine maintenance and refinish when needed.	\$0
Interior Walls	Breakroom	Fair	Wood paneling is dated and shows signs of wear, especially around the sink.	Remove wood paneling, install tile around sink, and repaint remainder of walls.	\$2,100*
Interior Windows	Interior window sills	Fair	Window sills and frames are showing signs of water and sun damage.	Refinish select window sills and frames.	\$10,000
Interior Doors	Door Knobs	Good	Door knobs are not accessible.	Review with historic preservation guidelines and consider replacing with lever.	\$9,000
Interior Doors	Vault Doors	Good	Vault doors are not accessible.	Consider replacing the vault doors at the time of remodel / renovation. At minimum, replace vault doors leading to rooms accessed by the public.	\$14,000*

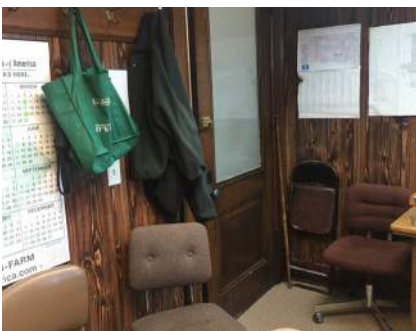
*Breakroom*

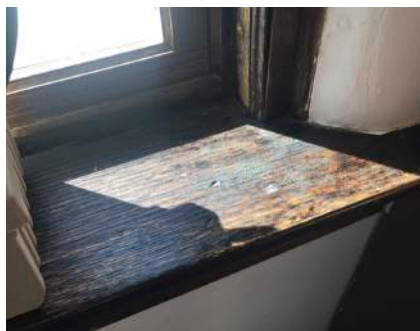
*Interior window and sill*

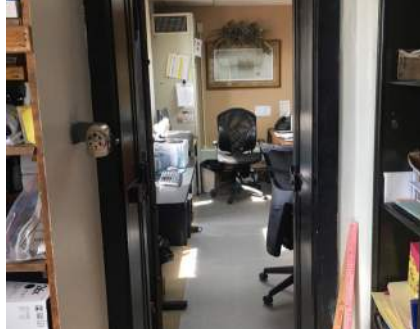
*Vault doors*

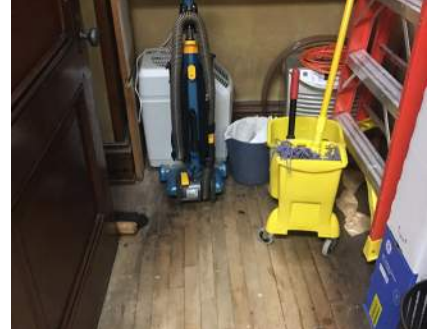
*Custodial closet—third floor*

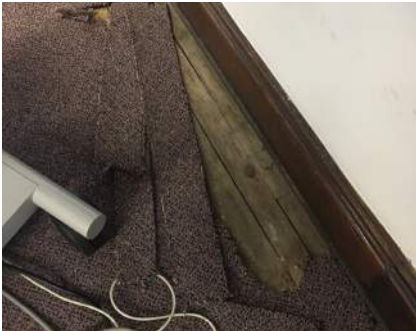
*Interior floors*

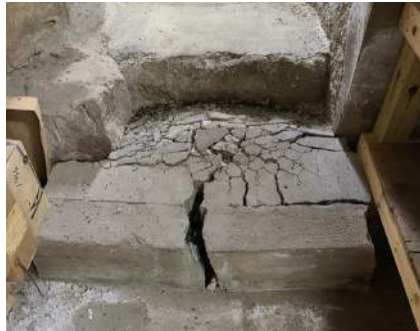
*Concrete step—basement*

Interior Floors	Courtroom—West Side	Poor	Carpet is torn and exposing hardwood flooring.	Replace carpet.	\$8,000*
Interior Floors	Concrete Step—Basement	Poor	Step is greatly deteriorated but poses no structural concern.	Replace the basement step.	\$1,400*
Interior Floors	Flooring—Planning and Zoning Office, Auditor's Vault, County Commission Room, and other areas	Poor	Carpet shows signs of wear and deterioration. Carpet is bubbling up in a few locations, is worn and has surpassed its useful service life.	Replace carpet throughout the building with carpet tile for ease of future replacement and maintenance.	\$38,300*
Interior Floors	Tile Flooring	Poor	Flooring tile adhesive may contain asbestos.	Test for asbestos and remove as needed.	\$3,500*
Interior Casework	County Offices	Fair	Work area lacks accessible counter and work surface.	Replace counter with a bi-level counter.	\$12,000*
Interior Casework	Planning and Zoning Office	Poor	Casework showing signs of wear.	Replace cabinetry.	\$2,400*

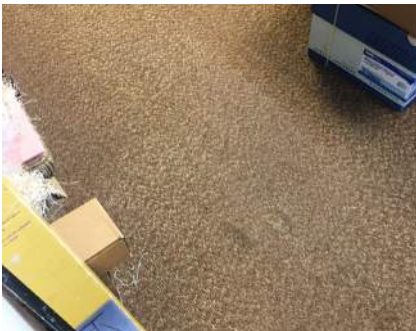
*Carpeted flooring—Auditors' vault*

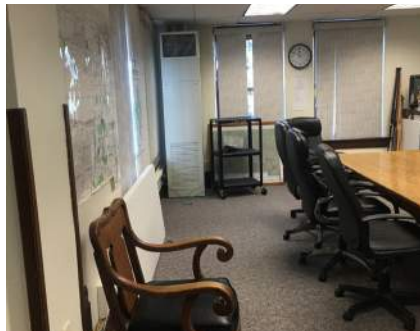
*Carpeted flooring—County Commission room*

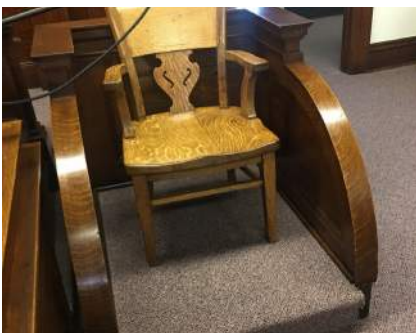
*Courtroom*

Interior Walls	Courtroom—South Wall	Fair	Wall paint is water damaged and peeling.	Investigate cause of water infiltration and repair.	\$0
Interior Walls	Foundation Wall—Exterior Basement Entrance	Fair	Mortar joints are deteriorated in basement wall.	Tuckpoint deteriorated mortar joints.	\$5,400
Interior Walls	Steel Framing—Tower	Good	Steel framing at tower is in good condition. No visible corrosion, bowing, or excessive deflection.	Perform regular inspections.	\$0
Interior Walls	Courtroom—Judge's Seat	Good	Woodwork and mural are in good condition.	Perform routine maintenance and refinish when needed.	\$0
Interior Walls	Breakroom	Fair	Wood paneling is dated and shows signs of wear, especially around the sink.	Remove wood paneling, install tile around sink, and repaint remainder of walls.	\$2,100*
Interior Windows	Interior window sills	Fair	Window sills and frames are showing signs of water and sun damage.	Refinish select window sills and frames.	\$10,000

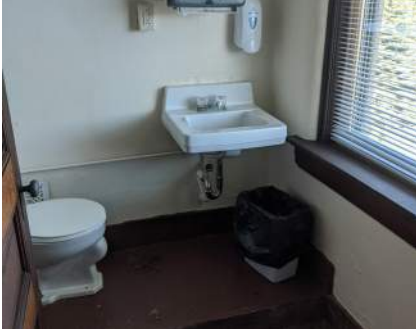
*Restroom fixtures and step*

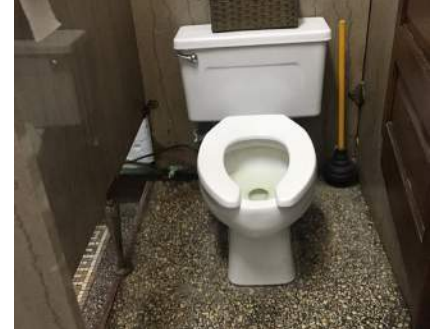
*Women's restroom*

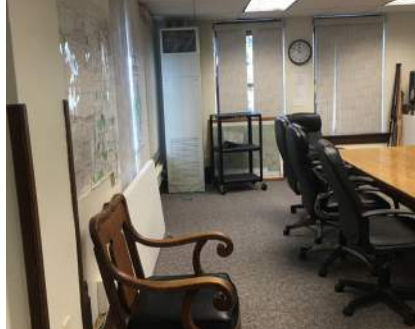
Meeting room vertical univent

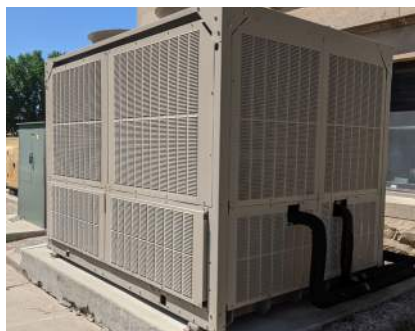
Chiller
